**Flood Control Project Maintenance
Levee Inspections**
LMA District Cover Sheet
Spring 2017 Levee Inspection Results

Sutter Maintenance Yard Maintenance Area 0007

Levee Inspection Report By Mile - Spring 2017

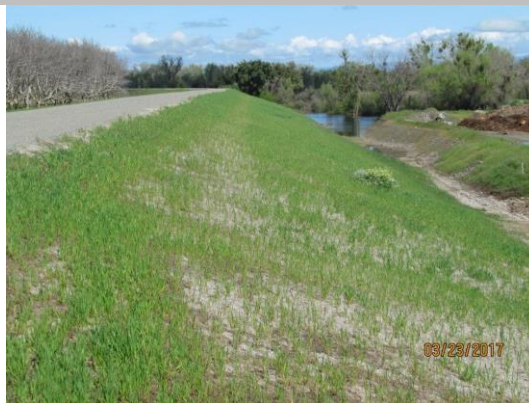
Photo 1 of 1 : SP_2017_MA0007_200_44_20170327_00129.jpg

LM Start	0.01	Rating **	A/W	Issue No.	44
LM End	11.39	Issue Type +	Ma	Location *	WS
Category	Earthen Levee			GPS Latitude/Longitude	
				Start	End
Item	Vegetation			39.311020 °	39.439702 °
				-121.637668 °	-121.641659 °
DWR ID	DWR_MA0007_01_s_2017_44				
Comment Code					
V1 : Control annual grass and weeds on the levee slopes and easements.					
Inspector Comment					
Controlled annual vegetation.

View of well maintained vegetation, water side looking upstream. Spring 2017.

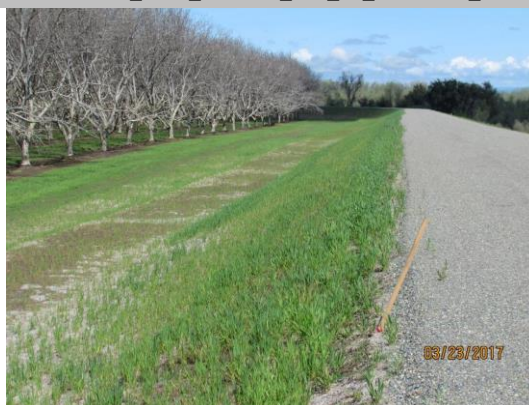
Photo 1 of 1 : SP_2017_MA0007_200_43_20170327_00130.jpg

LM Start	0.01	Rating **	A/W	Issue No.	43
LM End	11.89	Issue Type +	Ma	Location *	LS
Category	Earthen Levee			GPS Latitude/Longitude	
				Start	End
Item	Vegetation			39.311020 °	39.439702 °
				-121.637668 °	-121.641573 °
DWR ID	DWR_MA0007_01_s_2017_43				
Comment Code					
V1 : Control annual grass and weeds on the levee slopes and easements.					
Inspector Comment					
Controlled annual vegetation.

View of well maintained vegetation, land side looking upstream. Spring 2017.

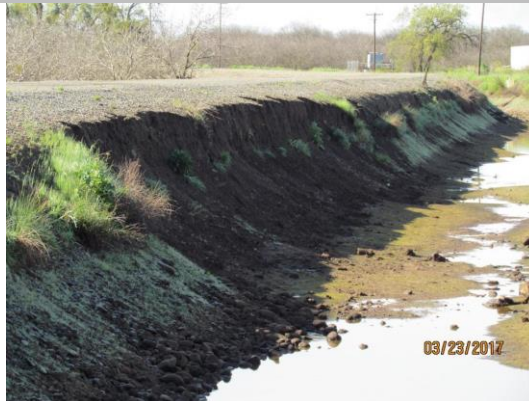
Photo 1 of 2 : SP_2017_MA0007_200_42_20170327_00118.jpg

LM Start	0.03	Rating **	U	Issue No.	42 (cont)
LM End	1.72	Issue Type +	Ma	Location *	LS

View of erosion in spring of 2017. This is continuing to get worse.

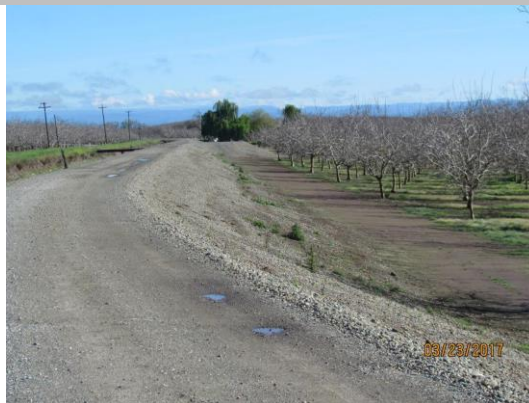
Photo 1 of 1 : SP_2017_MA0007_200_41_20170327_00117.jpg

LM Start	0.12	Rating **	A	Issue No.	41
LM End	1.02	Issue Type +	Ma	Location *	WS
Category	Earthen Levee			GPS Latitude/Longitude	
				Start	End
Item	Vegetation			39.312567 °	39.324458 °
				-121.636964 °	-121.631803 °
DWR ID	DWR_MA0007_01_s_2017_41				
Comment Code					
V1 : Control annual grass and weeds on the levee slopes and easements.					
Inspector Comment					
View of controlled vegetation.

View of controlled vegetation looking upstream on the water side. Spring 2017.

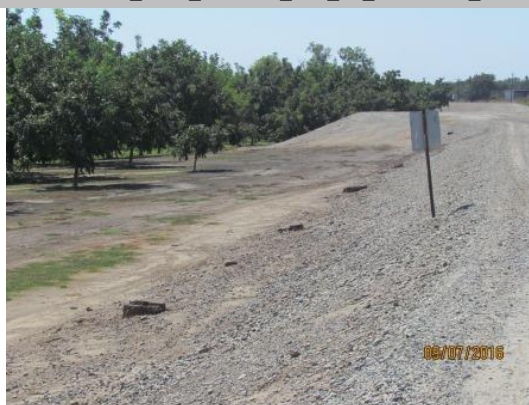
Photo 1 of 1 : SP_2017_MA0007_200_69_20170316_00016.jpg

LM Start	0.31	Rating **	N	Issue No.	69
LM End	0.37	Issue Type +	Ma	Location *	WS
Category	Earthen Levee			GPS Latitude/Longitude	
				Start	End
Item	Trim / Thin Trees			39.314991 °	39.315693 °
				-121.635038 °	-121.634459 °
DWR ID	DWR_MA0007_01_s_2016_69				
Comment Code					
T5 : Tree stumps.					
Inspector Comment					
Several tree stumps at levee toe.

View looking downstream of several tree stumps at the levee toe on the waterside.

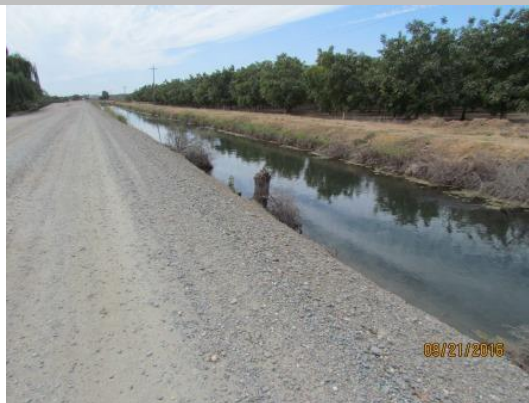
Photo 1 of 1 : SP_2017_MA0007_200_72_20170316_00018.jpg

LM Start	0.44	Rating **	U	Issue No.	72
LM End	0.44	Issue Type +	Ma	Location *	LS
Category	Earthen Levee			GPS Latitude/Longitude	
				Start	End
Item	Trim / Thin Trees			39.316527 °	39.316527 °
				-121.633800 °	-121.633800 °
DWR ID	DWR_MA0007_01_f_2016_72				
Comment Code					
T5 : Tree stumps.					
Inspector Comment					
The decomposing stump is next to the canal on the landside and needs to be removed.

View of a stump on the landside slope looking downstream. This stump is next to the canal on the landside and is decomposing and needs to be removed.

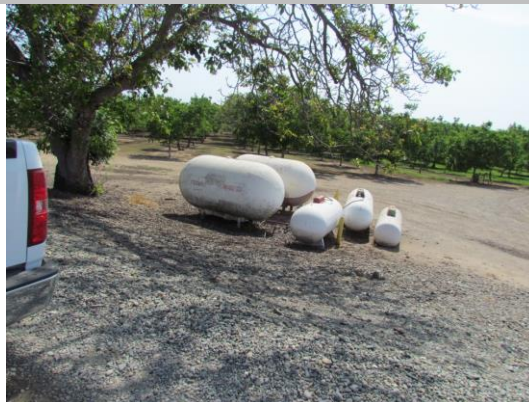
Photo 1 of 1 : SP_2017_MA0007_200_48_20170316_00008.jpg

LM Start	0.47	Rating **	M	Issue No.	48
LM End	0.47	Issue Type +	En	Location *	LS
Category	Earthen Levee			GPS Latitude/Longitude	
				Start	End
Item	Encroachments			39.316950 °	39.316950 °
				-121.633438 °	-121.633438 °
DWR ID	DWR_MA0007_01_s_2015_48				
Comment Code					
TA : Tank					
Inspector Comment

This view of the tanks was taken looking at the waterside of the levee facing upstream.

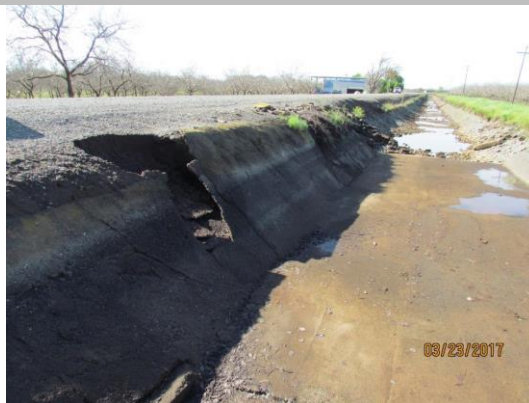
Photo 1 of 2 : SP_2017_MA0007_200_68_20170327_00119.jpg

LM Start	0.56	Rating **	U	Issue No.	68
LM End	0.56	Issue Type +	Ma	Location *	LS
Category	Earthen Levee			GPS Latitude/Longitude	
				Start	End
Item	Erosion / Bank Caving			39.317974 °	39.317974 °
				-121.632542 °	-121.632542 °
DWR ID	DWR_MA0007_01_s_2016_68				
Comment Code					
E1 : Note and monitor erosion site.					
Inspector Comment					
Eroding slope due to irrigation ditch on landside slope, looking downstream.

Inspection Spring 2017, erosion continues to get worse.

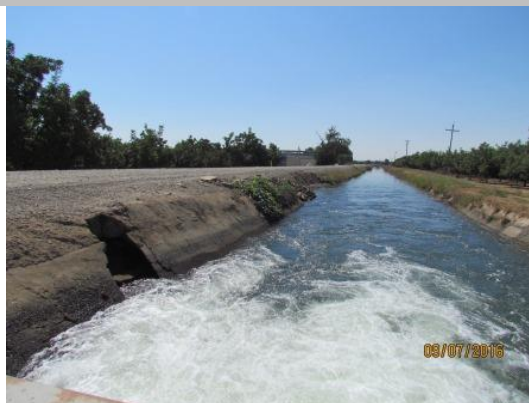
Photo 2 of 2 : SP_2017_MA0007_200_68_20170316_00015.jpg

LM Start	0.56	Rating **	U	Issue No.	68 (cont)
LM End	0.56	Issue Type +	Ma	Location *	LS

View of eroding slope due to irrigation ditch on landside slope, looking downstream. Fall 2016.

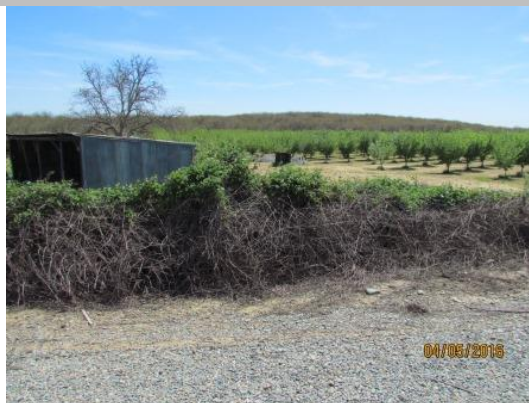
Photo 1 of 1 : SP_2017_MA0007_200_67_20170316_00014.jpg

LM Start	0.92	Rating **	A/W	Issue No.	67
LM End	0.92	Issue Type +	Ma	Location *	LS
Category	Earthen Levee			GPS Latitude/Longitude	
				Start	End
Item	Vegetation			39.323118 °	39.323118 °
				-121.632205 °	-121.632205 °
DWR ID	DWR_MA0007_01_s_2016_67				
Comment Code					
V2 : Remove the wild growth other than native grasses from the levee slopes.					
Inspector Comment

View of landside toe vegetation looking downstream.

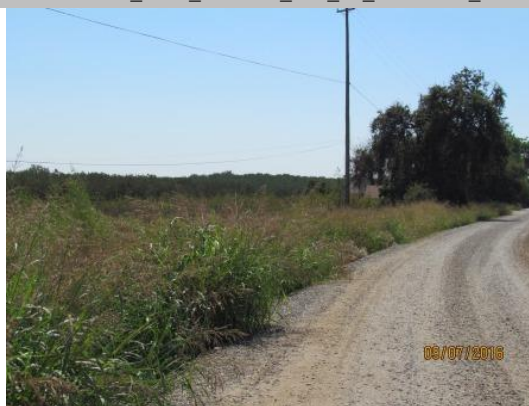
Photo 1 of 1 : SP_2017_MA0007_200_71_20170316_00017.jpg

LM Start	1.00	Rating **	M	Issue No.	71
LM End	1.12	Issue Type +	Ma	Location *	WS
Category	Earthen Levee			GPS Latitude/Longitude	
				Start	End
Item	Vegetation			39.324172 °	39.325938 °
				-121.631792 °	-121.631853 °
DWR ID	DWR_MA0007_01_f_2016_71				
Comment Code					
V1 : Control annual grass and weeds on the levee slopes and easements.					
Inspector Comment					
Waterside annual grasses that need to be maintained.

View of waterside annual grasses that need to be maintained. Looking downstream.

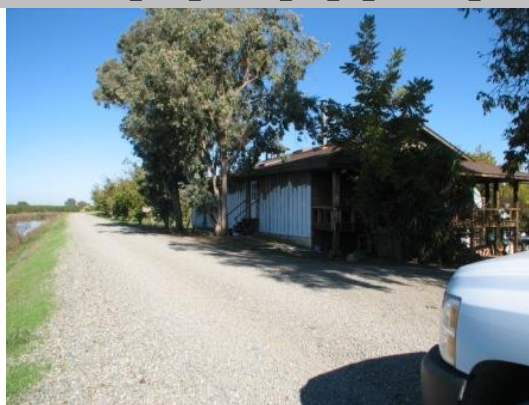
Photo 1 of 1 : SP_2017_MA0007_200_33_20170316_00001.jpg

LM Start	1.21	Rating **	U	Issue No.	33
LM End	1.21	Issue Type +	En	Location *	WS
Category	Earthen Levee			GPS Latitude/Longitude	
				Start	End
Item	Encroachments			39.327187 °	39.327187 °
				-121.632395 °	-121.632395 °
DWR ID	DWR_MA0007_01_s_2012_33				
Comment Code					
BU : Building					
Inspector Comment

Levee mile 1.21. This is a photo of the building on the waterside slope.

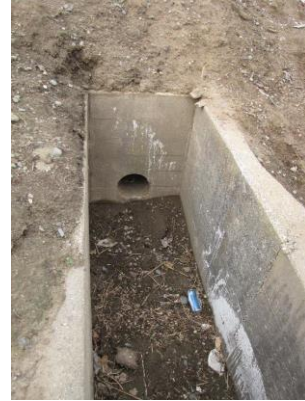
Photo 3 of 3 : UCIP_SP_2017_47833_65800.jpg

WS view-concrete headwall located on WS toe.

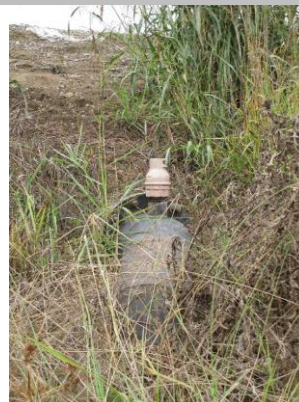
Photo 2 of 3 : UCIP_SP_2017_47834_65805.jpg

Exposed section of the pipe located on WS slope.

Comment Code						
Inspector Comment						
FS_ID:47834 DS_ID:20816 EP_NO: N/A Repair Type: Non-Urgent Crossing Status: Found UCIP Comments: 5/16/2016 Feather River West Levee Improvement Project--Levee currently under construction.6/10/2015 Crossing has been modified since last inspection. 3' black plastic pipe is now running through the metal pipe and the difference was capped and welded. 12/29/2014 Same as last inspection.5/19/2014 Same as last inspection.11/6/2013 Same as last inspection.5/13/2013 SBFCA project recommends removal. Permit number and owner in detailed report book.5/7/2013 Same as last inspection. Recommend finding owner.10/30/2012 Crossing was installed about 1 foot deep--need permit authorizing work FIELD_STRUCT_DESC: 12-inch steel irrigation pipe through the levee, 1 foot below the crown. Crossing on the landside (LS) is attached to weir above ground. Siphon breaker located on the waterside (WS). No opening on the WS. No permit has been identified since crossing was field discovered in 2012. FS Date: 5/16/2016 10:21:55 AM

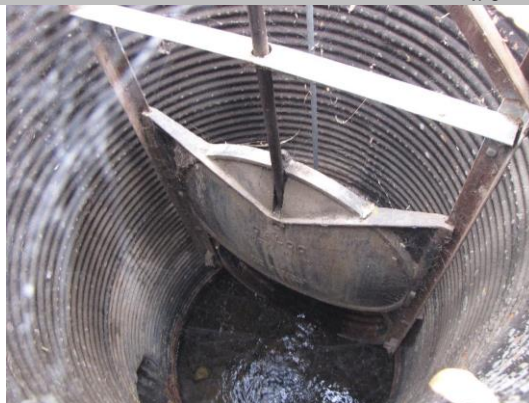
Photo 3 of 3 : UCIP_SP_2017_47836_65812.jpg

Comment Code						
Inspector Comment						
FS_ID:47836 DS_ID:16926 EP_NO: N/A Repair Type: Non-Urgent Crossing Status: Found UCIP Comments: 5/16/2016 Feather River West Levee Improvement Project--Levee currently under construction.6/10/2015 Debris still present in risers and pipes were not replaced with the SBFCA project.12/29/2014 Same as last inspection.5/19/2014 Same as last inspection.11/6/2013 Same as last inspection.5/13/2013 SBFCA project recommends replacing in accordance with title 23.5/7/2013 Same debris issue as last inspection. Recommend repairing top cover to prevent falls. Wheel to open gate chained and locked so could not verify gate operation.10/31/2012 Debris inside riser could prevent slide gate from closing. This crossing was listed in the USACE Periodic Inspections as ID# USACE_CESPK_MA07_2010_a_0060 however, no issues noted. FIELD_STRUCT_DESC: 1 of 2: 60-inch drainage pipe through the levee, 12.5 feet below the crown. Slide gates in 78-inch corrugated metal pipe (CMP) wells on the waterside (WS) slope. Concrete bulkhead on both WS and landside (LS) ends. Reinforced concrete spillway an the WS end. [Additional Reference(s): DWR Levee Log, 2005. USACE Sacramento O&M Manual 152, March 1957 (Station 1+90)] FS Date: 5/16/2016 10:22:42 AM

View inside of CMP riser with slide gate.

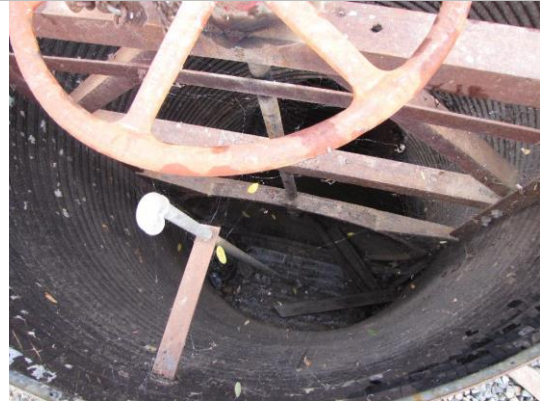
Photo 3 of 3 : UCIP_SP_2017_47837_65818.jpg

Comment Code						
Inspector Comment						
FS_ID:47837 DS_ID:17011 EP_NO: N/A Repair Type: Non-Urgent Crossing Status: Found UCIP Comments: 5/16/2016 Feather River West Levee Improvement Project--Levee currently under construction.6/10/2015 Debris still present inside riser and pipe was not replaced with the SBFCA project.12/29/2014 Same as last inspection.5/19/2014 Same as last inspection.11/6/2013 Same as last inspection.5/13/2013 SBFCA project recommends replacing in accordance with title 23.5/7/2013 Same as last inspection. Recommend constructing cover to prevent falls. Wheel to operate gate chained and locked so gate operation could not be verified.10/31/2012 no cover; debris inside riser could prevent slide gate from closing. This crossing was listed in the USACE Periodic Inspections as ID# USACE_CESPK_MA07_2010_a_0060 however, no issues noted. FIELD_STRUCT_DESC: 2 of 2: 60-inch drainage pipe through the levee, 12.5 feet below the crown. Slide gates in 78-inch corrugated metal pipe (CMP) wells on the waterside (WS) slope. Concrete bulkhead on both WS and landside (LS) ends. Reinforced concrete spillway an the WS end. [Additional Reference(s): DWR Levee Log, 2005. USACE Sacramento O&M Manual 152, March 1957 (Station 1+90)] FS Date: 5/16/2016 10:23:00 AM

View of crossing behind slide gate.

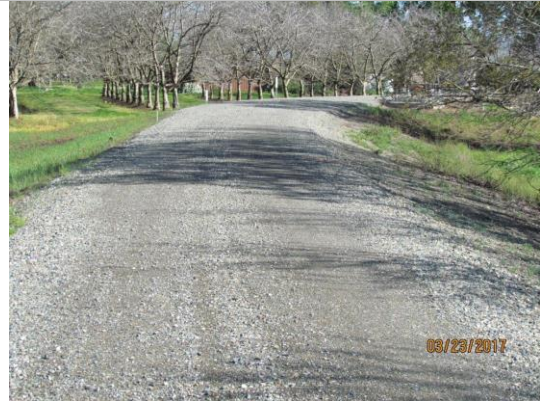
Photo 2 of 2 : SP_2017_MA0007_200_62_20170327_00120.jpg

LM Start	1.82	Rating **	A	Issue No.	62 (cont)	
LM End	2.53	Issue Type +	Ma	Location *	CR	
Category	Earthen Levee			GPS Latitude/Longitude		
				Start		End
Item	Crown Surface / Depressions / Rutting			39.335774 °		39.345322 °
				-121.633888 °		-121.629603 °
DWR ID	DWR_MA0007_01_f_2016_62					
Comment Code						
C1 : Add appropriate material and re-grade the levee to bring the crown above the design elevation.						
Inspector Comment						
This section of levee has been brought back to design elevation and the aggregate base placed.

View of levee that has been brought back to design elevation and the aggregate base placed. Looking upstream.Spring 2017.

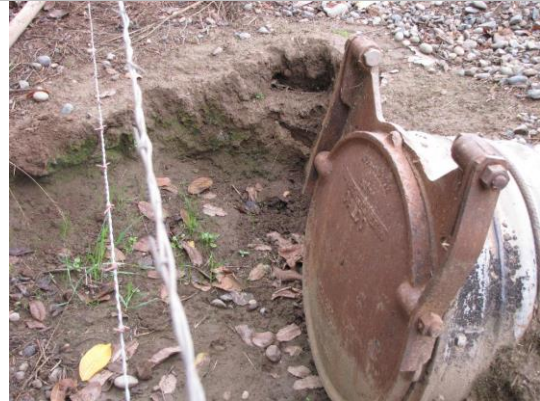
Photo 2 of 3 : UCIP_SP_2017_47975_65824.jpg

FS_ID:47975
DS_ID:16925
EP_NO: 18708
Repair Type: No Action Needed
Crossing Status: Found
UCIP Comments: 5/16/2016 Feather River West Levee Improvement Project--Levee currently under construction. Crossing, referenced as STA 1777+00, will be removed and replaced as indicated in the project Plans for Construction of Feather River West Levee Project, Project Area A, Feather River West Levee Improvement Plans, Sta 1765+00 to 2368+26, Volume 3 of 5.6/10/2015 Pipe appears to be in good condition. No noticeable issues to report.12/29/2014 Same as last inspection.5/19/2014 Same as last inspection.11/6/2013 Same as last inspection.5/13/2013 SBFCA project recommends replacing in accordance with title 23.10/31/2012 WS gate appears to be working. This crossing was listed in the USACE Periodic Inspections as ID# USACE_CESPK_MA07_2010_a_0062 for broken flap gate on WS and half blocked by soil/vegetation on LS.

View of flap gate located on WS toe.

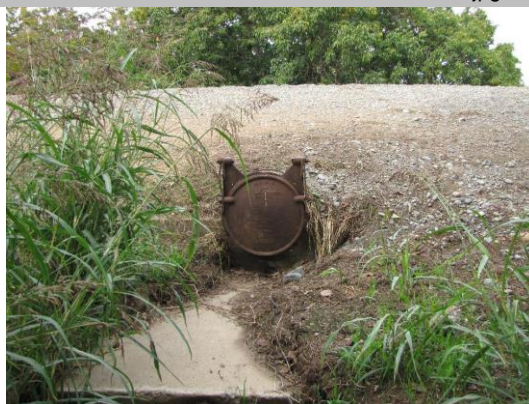
Photo 2 of 3 : UCIP_SP_2017_47976_65832.jpg

Crossing with concrete apron and flap gate located on WS end.

FS_ID:47976
DS_ID:16924
EP_NO: 18709
Repair Type: No Action Needed
Crossing Status: Found
UCIP Comments: 5/16/2016 Feather River West Levee Improvement Project--Levee currently under construction. Crossing, referenced as STA 1785+24, will be removed and replaced as indicated in the project Plans for Construction of Feather River West Levee Project, Project Area A, Feather River West Levee Improvement Plans, Sta 1765+00 to 2368+26, Volume 3 of 5.6/10/2015 Pipe appears in good condition. No noticeable issues to report.12/29/2014 Same as last inspection.5/19/2014 Same as last inspection.11/6/2013 Same as last inspection.5/13/2013 SBFCA project recommends replacing in accordance with title 23.5/7/2013 Periodic inspection issue has been resolved and gate is clear to operate normally.10/31/2012 This crossing was listed in the USACE Periodic Inspections as ID# USACE_CESPK_MA07_2010_a_0070 for inoperable flap gate filled with gravel.

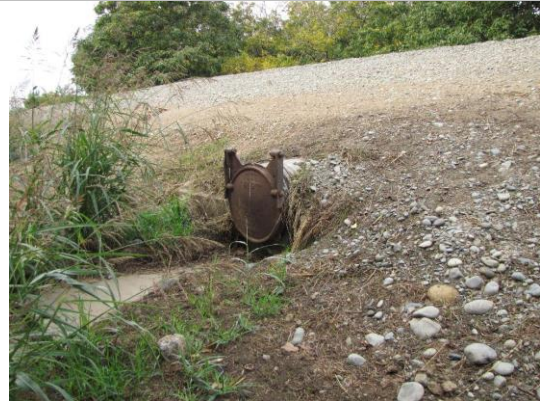
Photo 3 of 3 : UCIP_SP_2017_47976_65831.jpg

FIELD_STRUCT_DESC: 24-inch corrugated metal drainage pipe through the levee, 7 feet below the crown. Flap gate on the waterside (WS) end. Concrete headwall on both WS and landside (LS). Concrete apron located on the WS end. (Permit No. 18709, 2011 - Sandra Waller, permit issued in 2011 to continue the use of existing 24-inch pipe) [Additional Reference(s): DWR Levee Log, 2005. USACE Sacramento O&M Manual 152, March 1957 (Station 19+30)]
FS Date: 5/16/2016 10:23:00 AM

View of levee slope at crossing looking downstream.

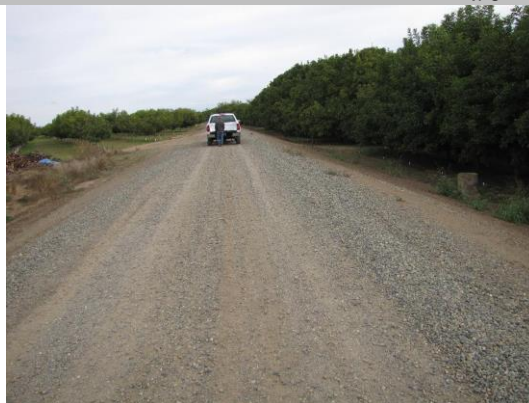
Photo 1 of 3 : UCIP_SP_2017_47998_65837.jpg

Comment Code					
Inspector Comment					
FS_ID:47998 DS_ID:16923 EP_NO: 18710 Repair Type: Non-Urgent Crossing Status: Found UCIP Comments: 5/16/2016 Feather River West Levee Improvement Project--Levee currently under construction. Crossing, referenced as 1792+96, will be removed and replaced with a 36-inch pipe as indicated in the project Plans for Construction of Feather River West Levee Project, Project Area A, Feather River West Levee Improvement Plans, Sta 1765+00 to 2368+26, Volume 3 of 5.6/10/2015 Small erosion still present around concrete standpipe. Think its just caused by rain runoff. 12/29/2014 Same as last inspection.5/19/2014 Same as last inspection.11/6/2013 Same as last inspection.5/13/2013 SBFCA project recommends removal.5/7/2013 Same as last inspection. Need to investigate source of WS erosion.10/31/2012 Erosion on WS around concrete standpipe--might be leaking. Burrow activity present on WS slope, unable to determine if structure is still being used. This crossing was listed in the USACE Periodic Inspections as ID# USACE_CESPK_MA07_2010_a_0075 however, no issues noted. FIELD_STRUCT_DESC: *ABANDONED* 24-inch corrugated metal irrigation pipe through the levee, 12.7 feet below the crown. Flap gate on the waterside (WS) end. Concrete distribution box at the WS toe. Second concrete distribution box connected to deep well pump located 400-500 feet from landside (LS) toe. (Permit No. 18710 - 2011, Sandra Waller, permit issued in 2011 to continue the use of existing 24-inch pipe) [Additional Reference(s): DWR Levee Log, 2005. USACE Sacramento O&M Manual 152, March 1957 (Station 28+00)] FS Date: 5/16/2016 10:24:00 AM

View of levee crown looking upstream.

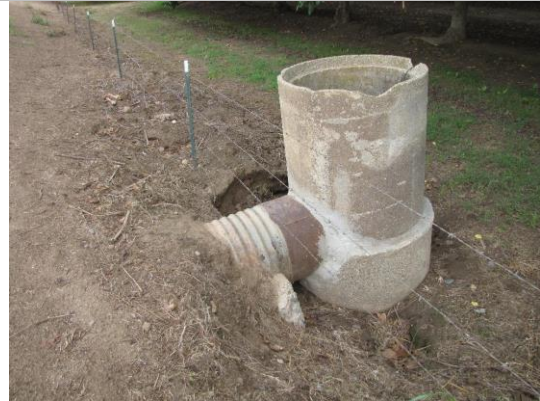
Photo 2 of 3 : UCIP_SP_2017_47998_65836.jpg

Comment Code						
Inspector Comment						
FS_ID:47998						
DS_ID:16923						
EP_NO: 18710						
Repair Type: Non-Urgent						
Crossing Status: Found						
UCIP Comments: 5/16/2016 Feather River West Levee Improvement Project--Levee currently under construction. Crossing, referenced as 1792+96, will be removed and replaced with a 36-inch pipe as indicated in the project Plans for Construction of Feather River West Levee Project, Project Area A, Feather River West Levee Improvement Plans, Sta 1765+00 to 2368+26, Volume 3 of 5.6/10/2015 Small erosion still present around concrete standpipe. Think its just caused by rain runoff. 12/29/2014 Same as last inspection.5/19/2014 Same as last inspection.11/6/2013 Same as last inspection.5/13/2013 SBFCA project recommends removal.5/7/2013 Same as last inspection. Need to investigate source of WS erosion.10/31/2012 Erosion on WS around concrete standpipe--might be leaking. Burrow activity present on WS slope, unable to determine if structure is still being used. This crossing was listed in the USACE Periodic Inspections as ID# USACE_CESPK_MA07_2010_a_0075 however, no issues noted.

FIELD_STRUCT_DESC: *ABANDONED* 24-inch corrugated metal irrigation pipe through the levee, 12.7 feet below the crown. Flap gate on the waterside (WS) end. Concrete distribution box at the WS toe. Second concrete distribution box connected to deep well pump located 400-500 feet from landside (LS) toe. (Permit No. 18710 - 2011, Sandra Waller, permit issued in 2011 to continue the use of existing 24-inch pipe) [Additional Reference(s): DWR Levee Log, 2005. USACE Sacramento O&M Manual 152, March 1957 (Station 28+00)]						
FS Date: 5/16/2016 10:24:00 AM

View of crossing and standpipe located on WS end.

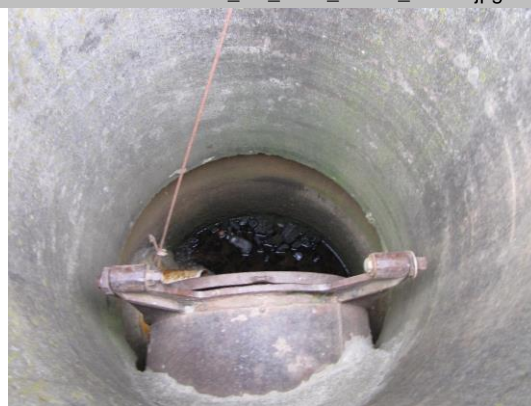
Photo 3 of 3 : UCIP_SP_2017_47998_65841.jpg

Comment Code					
Inspector Comment					
FS_ID:47998 DS_ID:16923 EP_NO: 18710 Repair Type: Non-Urgent Crossing Status: Found UCIP Comments: 5/16/2016 Feather River West Levee Improvement Project--Levee currently under construction. Crossing, referenced as 1792+96, will be removed and replaced with a 36-inch pipe as indicated in the project Plans for Construction of Feather River West Levee Project, Project Area A, Feather River West Levee Improvement Plans, Sta 1765+00 to 2368+26, Volume 3 of 5.6/10/2015 Small erosion still present around concrete standpipe. Think its just caused by rain runoff. 12/29/2014 Same as last inspection.5/19/2014 Same as last inspection.11/6/2013 Same as last inspection.5/13/2013 SBFCA project recommends removal.5/7/2013 Same as last inspection. Need to investigate source of WS erosion.10/31/2012 Erosion on WS around concrete standpipe--might be leaking. Burrow activity present on WS slope, unable to determine if structure is still being used. This crossing was listed in the USACE Periodic Inspections as ID# USACE_CESPK_MA07_2010_a_0075 however, no issues noted. FIELD_STRUCT_DESC: *ABANDONED* 24-inch corrugated metal irrigation pipe through the levee, 12.7 feet below the crown. Flap gate on the waterside (WS) end. Concrete distribution box at the WS toe. Second concrete distribution box connected to deep well pump located 400-500 feet from landside (LS) toe. (Permit No. 18710 - 2011, Sandra Waller, permit issued in 2011 to continue the use of existing 24-inch pipe) [Additional Reference(s): DWR Levee Log, 2005. USACE Sacramento O&M Manual 152, March 1957 (Station 28+00)] FS Date: 5/16/2016 10:24:00 AM

Inside view of standpipe located on WS end.

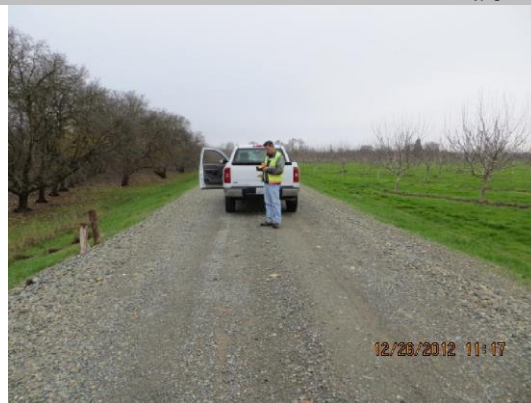
Photo 1 of 3 : UCIP_SP_2017_47933_65844.jpg

Comment Code					
Inspector Comment					
FS_ID:47933 DS_ID:20817 EP_NO: N/A Repair Type: Non-Urgent Crossing Status: Found UCIP Comments: 5/16/2016 Feather River West Levee Improvement Project--Levee currently under construction. New gate valve, referenced as STA 1799+44, will be installed as indicated in the project Plans for Construction of Feather River West Levee Project, Project Area A, Feather River West Levee Improvement Plans, Sta 1765+00 to 2368+26, Volume 3 of 5.6/10/2015 Air vac is still bent over.12/29/2014 Same as last inspection.5/19/2014 Same as last inspection.11/6/2013 Air vac bent over and both metal posts are laying at toe of levee.5/13/2013 Permit number and owner in detailed report book.5/7/2013 Need to find owner of structure.10/30/2012 Need permit authorizing work. FIELD_STRUCT_DESC: Air vac located on the waterside (WS) shoulder protected by two metal posts. No other signs of encroachment are present. No permit has been identified since crossing was field discovered in 2012. FS Date: 5/16/2016 10:24:00 AM

LM Start	2.36	Rating **	M	Issue No.	80 (cont)
LM End	2.36	Issue Type +	En	Location *	CR

Overview of levee crown looking downstream at crossing.

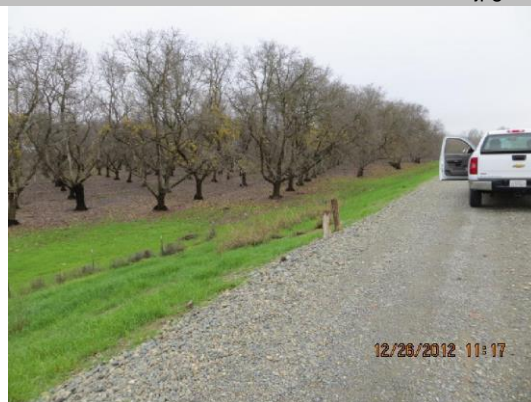
Photo 2 of 3 : UCIP_SP_2017_47933_65843.jpg

View of WS at crossing.

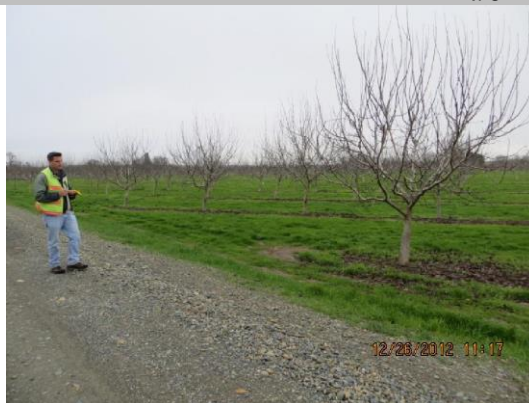
Photo 3 of 3 : UCIP_SP_2017_47933_65847.jpg

Comment Code						
Inspector Comment						
FS_ID:47933 DS_ID:20817 EP_NO: N/A Repair Type: Non-Urgent Crossing Status: Found UCIP Comments: 5/16/2016 Feather River West Levee Improvement Project--Levee currently under construction. New gate valve, referenced as STA 1799+44, will be installed as indicated in the project Plans for Construction of Feather River West Levee Project, Project Area A, Feather River West Levee Improvement Plans, Sta 1765+00 to 2368+26, Volume 3 of 5.6/10/2015 Air vac is still bent over.12/29/2014 Same as last inspection.5/19/2014 Same as last inspection.11/6/2013 Air vac bent over and both metal posts are laying at toe of levee.5/13/2013 Permit number and owner in detailed report book.5/7/2013 Need to find owner of structure.10/30/2012 Need permit authorizing work. FIELD_STRUCT_DESC: Air vac located on the waterside (WS) shoulder protected by two metal posts. No other signs of encroachment are present. No permit has been identified since crossing was field discovered in 2012. FS Date: 5/16/2016 10:24:00 AM

View of WS at crossing.

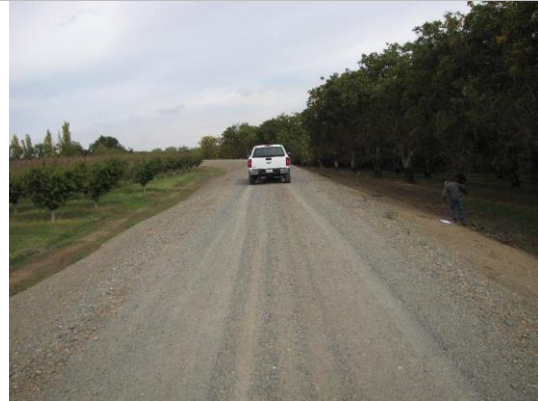
Photo 1 of 3 : UCIP_SP_2017_48000_65849.jpg

FS_ID:48000
DS_ID:16910
EP_NO: N/A
Repair Type: Non-Urgent
Crossing Status: Found
UCIP Comments: 5/16/2016 Feather River West Levee Improvement Project--Levee currently under construction. Crossing, referenced as STA 1809+65, will be removed and replaced as indicated in the project Plans for Construction of Feather River West Levee Project, Project Area A, Feather River West Levee Improvement Plans, Sta 1765+00 to 2368+26, Volume 3 of 5.6/10/2015 Pipe appears in good condition. No noticeable issues to report.12/29/2014 Same as last inspection.5/19/2014 Same as last inspection.11/6/2013 Same as last inspection.5/13/2013 SBFCA project recommends replacing in accordance with title 23.5/7/2013 WS sediment blocking gate has been cleared so gate can operate normally. Recommend clearing sediment buildup at mouth of pipe on LS.10/31/2012 WS headwall may be present not visible due to soil cover. Sediment build up on LS headwall--clear. This crossing was listed in the USACE Periodic Inspections as ID# USACE_CESPK_MA07_2010_a_0083 for inoperable gate.

LM Start	2.56	Rating **	M	Issue No.	81 (cont)
LM End	2.56	Issue Type +	Ma	Location *	CR

View of levee crown looking upstream.

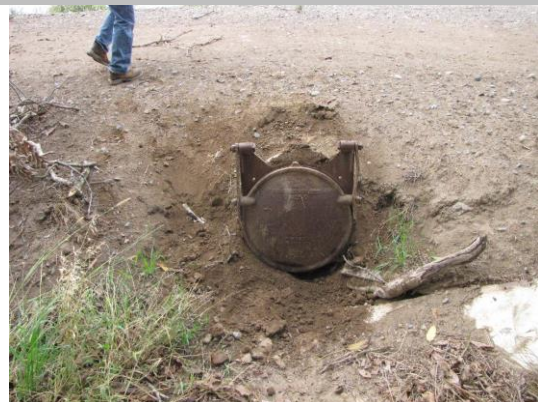
Photo 2 of 3 : UCIP_SP_2017_48000_65852.jpg

View of flap gate located on WS.

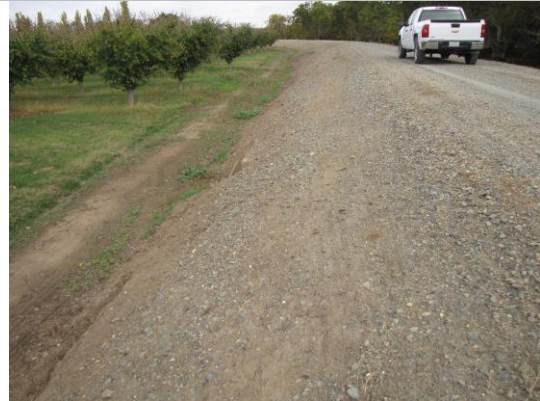
Photo 3 of 3 : UCIP_SP_2017_48000_65851.jpg

Comment Code						
Inspector Comment						
FS_ID:48000 DS_ID:16910 EP_NO: N/A Repair Type: Non-Urgent Crossing Status: Found UCIP Comments: 5/16/2016 Feather River West Levee Improvement Project--Levee currently under construction. Crossing, referenced as STA 1809+65, will be removed and replaced as indicated in the project Plans for Construction of Feather River West Levee Project, Project Area A, Feather River West Levee Improvement Plans, Sta 1765+00 to 2368+26, Volume 3 of 5.6/10/2015 Pipe appears in good condition. No noticeable issues to report.12/29/2014 Same as last inspection.5/19/2014 Same as last inspection.11/6/2013 Same as last inspection.5/13/2013 SBFCA project recommends replacing in accordance with title 23.5/7/2013 WS sediment blocking gate has been cleared so gate can operate normally. Recommend clearing sediment buildup at mouth of pipe on LS.10/31/2012 WS headwall may be present not visible due to soil cover. Sediment buildup on LS headwall--clear. This crossing was listed in the USACE Periodic Inspections as ID# USACE_CESPK_MA07_2010_a_0083 for inoperable gate. FIELD_STRUCT_DESC: 24-inch corrugated metal pipe through the levee, 6.7 feet below the crown. Flap gate on the waterside (WS) end. Concrete headwall at both WS and landside (LS) toes. (USACE O&M Manual, 1957) [Additional Reference(s): DWR Levee Log, 2005. USACE Sacramento O&M Manual 152, March 1957 (Station 44+50)] FS Date: 5/16/2016 10:25:00 AM

View of LS slope.

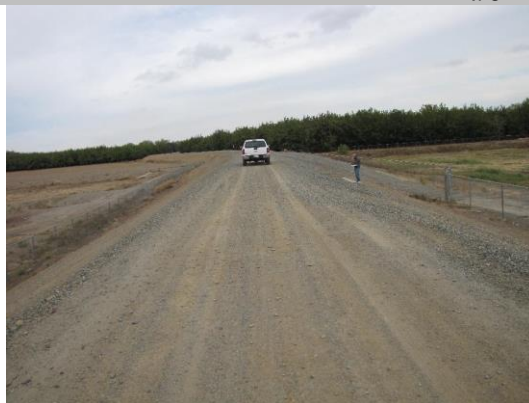
Photo 1 of 3 : UCIP_SP_2017_49199_65855.jpg

FS_ID:49199
DS_ID:16921
EP_NO: N/A
Repair Type: Non-Urgent
Crossing Status: Found
UCIP Comments: 5/16/2016 Feather River West Levee Improvement Project--Levee currently under construction. Crossing, referenced as STA 1818+72, will be removed and replaced with a 36-inch pipe as indicated in the project Plans for Construction of Feather River West Levee Project, Project Area A, Feather River West Levee Improvement Plans, Sta 1765+00 to 2368+26, Volume 3 of 5.6/10/2015 Riser is still damaged and cant locate signs of pipe on LS.12/29/2014 Same as last inspection.5/19/2014 Same as last inspection.11/6/2013 Same as last inspection.5/13/2013 SBFCA project recommends relacing in accordance with title 23.5/7/2013 Same as last inspection, rodent activity near crossing, need to repair rodent hole on WS.10/31/2012 CMP riser damage-repair needed. Unable to locate pipe on LS. This crossing was listed in the USACE Periodic Inspections as ID# USACE_CESPK_MA07_2010_a_0090 however, no issues noted.

LM Start	2.73	Rating **	M	Issue No.	82 (cont)
LM End	2.73	Issue Type +	Ma	Location *	CR

Overview of levee crown looking upstream.

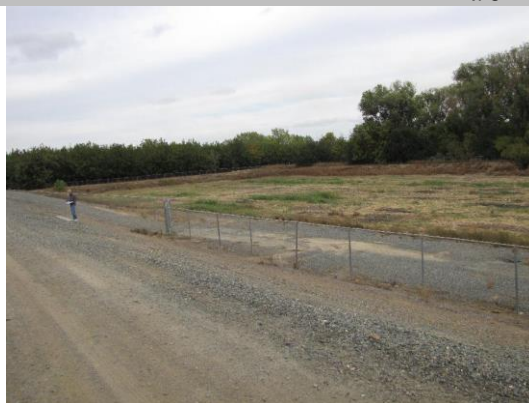
Photo 2 of 3 : UCIP_SP_2017_49199_65854.jpg

View of WS slope looking upstream. Matt is standing near CMP riser.

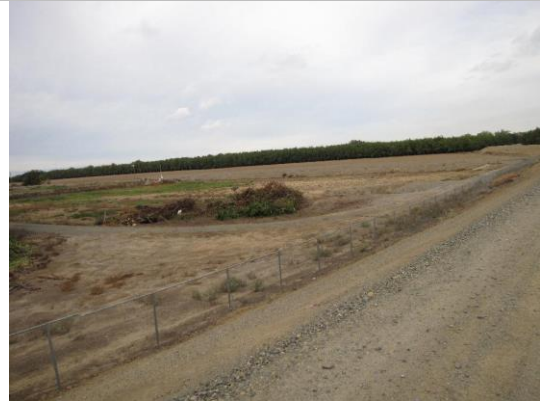
Photo 3 of 3 : UCIP_SP_2017_49199_65853.jpg

Comment Code						
Inspector Comment						
FS_ID:49199 DS_ID:16921 EP_NO: N/A Repair Type: Non-Urgent Crossing Status: Found UCIP Comments: 5/16/2016 Feather River West Levee Improvement Project--Levee currently under construction. Crossing, referenced as STA 1818+72, will be removed and replaced with a 36-inch pipe as indicated in the project Plans for Construction of Feather River West Levee Project, Project Area A, Feather River West Levee Improvement Plans, Sta 1765+00 to 2368+26, Volume 3 of 5.6/10/2015 Riser is still damaged and cant locate signs of pipe on LS.12/29/2014 Same as last inspection.5/19/2014 Same as last inspection.11/6/2013 Same as last inspection.5/13/2013 SBFCA project recommends relacing in accordance with title 23.5/7/2013 Same as last inspection, rodent activity near crossing, need to repair rodent hole on WS.10/31/2012 CMP riser damage-repair needed. Unable to locate pipe on LS. This crossing was listed in the USACE Periodic Inspections as ID# USACE_CESPK_MA07_2010_a_0090 however, no issues noted. FIELD_STRUCT_DESC: 24-inch corrugated metal drainage pipe through the levee, 25.5 feet below the crown. Slide gate in 36-inch corrugated metal pipe (CMP) riser on the waterside (WS) slope. [Additional Reference(s): DWR Levee Log, 2005. USACE Sacramento O&M Manual 152, March 1957 (Station 52+50)] FS Date: 5/16/2016 10:25:00 AM

View of LS.

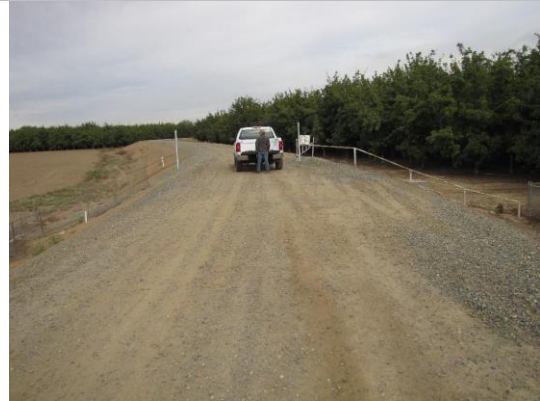
Photo 1 of 3 : UCIP_SP_2017_47937_65864.jpg

FS_ID:47937
DS_ID:16919
EP_NO: 5722
Repair Type: Non-Urgent
Crossing Status: Indicator Found
UCIP Comments: 5/16/2016 Feather River West Levee Improvement Project--Levee currently under construction. Both 12-inch and 24-inch, referenced as STA 1823+01, will be removed as indicated in the project Plans for Construction of Feather River West Levee Project, Project Area A, Feather River West Levee Improvement Plans, Sta 1765+00 to 2368+26, Volume 3 of 5.6/10/2015 Same as last inspection.12/29/2014 Same as last inspection.5/19/2014 Same as last inspection.11/6/2013 Same as last inspection.5/13/2013 SBFCA project recommends relacing in accordance with title 23.5/7/2013 Same as last inspection. WS sediment drop above concrete stand pipe. Coordinate with owner and levee inspector to address issue.10/31/2012 dense burrow activity on crown and slopes. FIELD_STRUCT_DESC: 12-inch cement coated and lined steel sewer pipe sleeved through the existing 24-inch corrugated metal pipe with annular space pressure grouted through the levee, 21.4 feet below the crown. A 36-inch reinforced concrete pipe riser is located on the waterside (WS). Slide gate in 36-inch reinforced concrete pipe riser located on the WS slope. (Permit No. 5722, 1968 - City of Gridley) [Additional Reference(s): DWR Levee Log, 2005. USACE Sacramento O&M Manual 152, March 1957 (Station 56+90)]

LM Start	2.81	Rating **	M	Issue No.	83 (cont)
LM End	2.81	Issue Type +	En	Location *	CR

Overview of levee crown looking upstream.

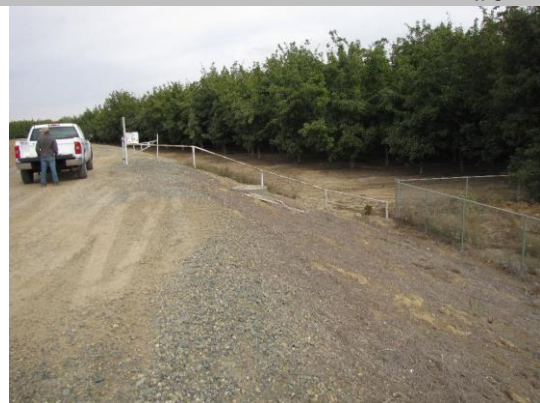
Photo 2 of 3 : UCIP_SP_2017_47937_65863.jpg

View of WS slope looking at crossing.

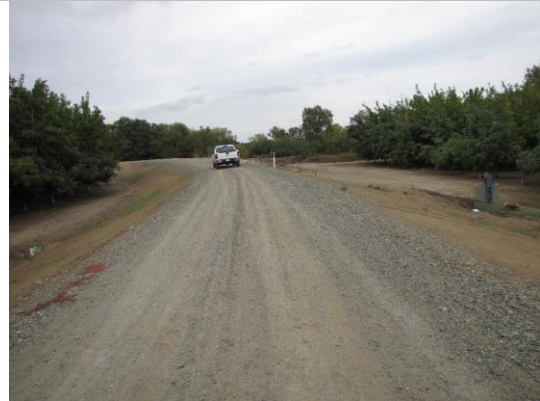
Photo 1 of 3 : UCIP_SP_2017_47981_65872.jpg

FS_ID:47981
DS_ID:16918
EP_NO: N/A
Repair Type: Non-Urgent
Crossing Status: Found
UCIP Comments: 5/16/2016 Feather River West Levee Improvement Project--Levee currently under construction. 12-inch and 24-inch crossings, referenced as STA 1834+42, will be removed and replaced with a 36-inch pipe as indicated in the project Plans for Construction of Feather River West Levee Project, Project Area A, Feather River West Levee Improvement Plans, Sta 1765+00 to 2368+26, Volume 3 of 5.6/10/2015 Same as last inspection.12/29/2014 Same as last inspection.5/19/2014 Same as last inspection.11/6/2013 Same as last inspection.5/13/2013 SBFCA project recommends relacing in accordance with title 23.5/7/2013 Structure does appear to be altered. Contact Levee Inspector to pursue NOV.10/31/2012 Unable to determine if this crossing has been altered, will need to coordinate with levee inspector. This crossing was listed in the USACE Periodic Inspection as ID# USACE_CESPK_MA07_2010_a_0104 however, no issues reported.

LM Start	3.02	Rating **	M	Issue No.	84 (cont)
LM End	3.02	Issue Type +	Ma	Location *	CR

View of levee crown looking upstream at crossing.

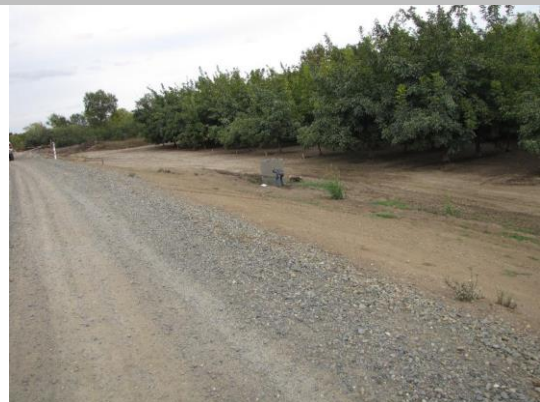
Photo 2 of 3 : UCIP_SP_2017_47981_65871.jpg

View of WS looking at crossing.

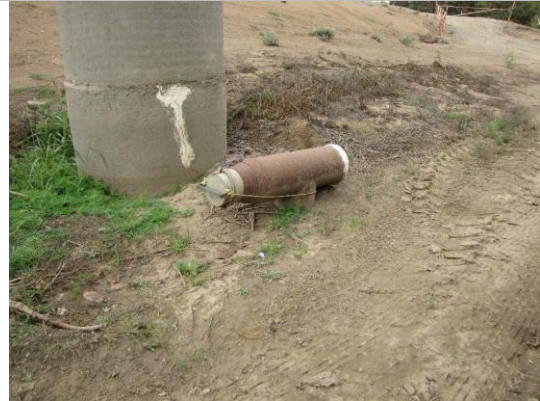
Photo 3 of 3 : UCIP_SP_2017_47981_65875.jpg

Comment Code						
Inspector Comment						
FS_ID:47981 DS_ID:16918 EP_NO: N/A Repair Type: Non-Urgent Crossing Status: Found UCIP Comments: 5/16/2016 Feather River West Levee Improvement Project--Levee currently under construction. 12-inch and 24-inch crossings, referenced as STA 1834+42, will be removed and replaced with a 36-inch pipe as indicated in the project Plans for Construction of Feather River West Levee Project, Project Area A, Feather River West Levee Improvement Plans, Sta 1765+00 to 2368+26, Volume 3 of 5.6/10/2015 Same as last inspection.12/29/2014 Same as last inspection.5/19/2014 Same as last inspection.11/6/2013 Same as last inspection.5/13/2013 SBFCA project recommends relacing in accordance with title 23.5/7/2013 Structure does appear to be altered. Contact Levee Ispector to pursue NOV.10/31/2012 Unable to determine if this crossing has been altered, will need to coordinate with levee inspector. This crossing was listed in the USACE Periodic Inspection as ID# USACE_CESPK_MA07_2010_a_0104 however, no issues reported. FIELD_STRUCT_DESC: 12-inch steel drainage pipe sleeved through existing 24-inch pipe. The 24-inch corrugated metal pipe goes through the levee at approximately 15.3 feet below the crown. Flap gate inside riser on the WS end. A reinforced concrete pipe riser located on the waterside (WS). [Additional Reference(s): DWR Levee Log, 2005. USACE Sacramento O&M Manual 152, March 1957 (Station 69+00)] FS Date: 5/16/2016 10:26:00 AM

View of additional appurtances associated with crossing.

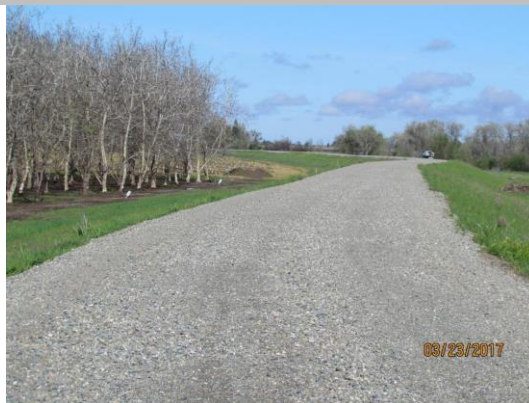
Photo 1 of 2 : SP_2017_MA0007_200_60_20170327_00122.jpg

LM Start	3.32	Rating **	A/W	Issue No.	60
LM End	4.29	Issue Type +	Ma	Location *	CR
Category	Earthen Levee			GPS Latitude/Longitude	
				Start	End
Item	Crown Surface / Depressions / Rutting			39.354596 °	39.365418 °
				-121.635404 °	-121.646539 °
DWR ID	DWR_MA0007_01_f_2016_60				
Comment Code					
C1 : Add appropriate material and re-grade the levee to bring the crown above the design elevation.					
Inspector Comment					
This section of levee has been brought back to design elevation and the aggregate base placed.

View of levee that has been brought back to design elevation and the aggregate base placed. Looking upstream. Spring 2017

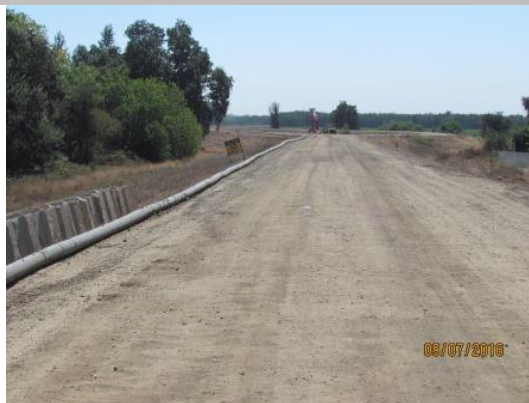
Photo 2 of 2 : SP_2017_MA0007_200_60_20170316_00011.jpg

LM Start	3.32	Rating **	A/W	Issue No.	60 (cont)
LM End	4.29	Issue Type +	Ma	Location *	CR

View of levee that has been brought back to design elevation but still needs the aggregate base placed. Looking down stream. Fall 2016.

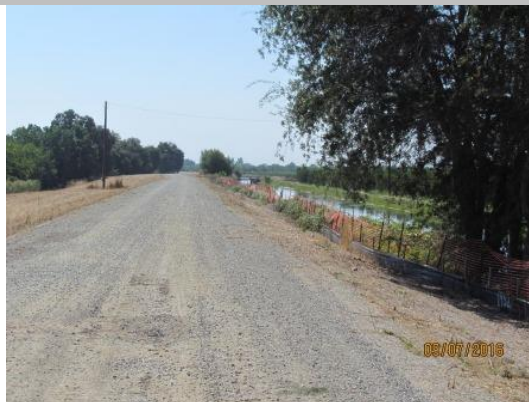
Photo 1 of 1 : SP_2017_MA0007_200_39_20170316_00002.jpg

LM Start	4.39	Rating **	M	Issue No.	39
LM End	5.35	Issue Type +	En	Location *	LS
Category	Earthen Levee			GPS Latitude/Longitude	
				Start	End
Item	Encroachments			39.366547 °	39.380071 °
				-121.647523 °	-121.650558 °
DWR ID	DWR_MA0007_01_s_2012_39				
Comment Code					
DT : Ditch					
Inspector Comment					
Landside irrigation ditch.

View of Landside ditch.

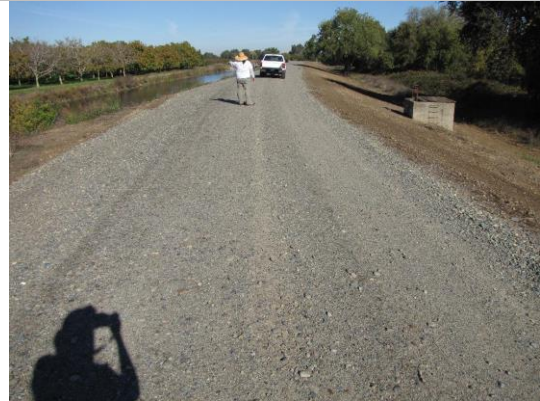
Photo 1 of 3 : UCIP_SP_2017_48003_65891.jpg

FS_ID:48003
DS_ID:16943
EP_NO: N/A
Repair Type: Non-Urgent
Crossing Status: Found
UCIP Comments: 5/16/2016 Feather River West Levee Improvement Project--Levee currently under construction. Crossing, referenced as STA 1934+54, will be removed and replaced with a 12-inch pipe as indicated in the project Plans for Construction of Feather River West Levee Project, Project Area A, Feather River West Levee Improvement Plans, Sta 1765+00 to 2368+26, Volume 3 of 5.6/10/2015 Pipe has been removed during the SBFA project. It was originally listed to be replaced so it may be added back in on a later date.12/29/2014 Same as last inspection.5/19/2014 Same as last inspection.11/7/2013 Same as last inspection.5/13/2013 SBFA project recommends relacing in accordance with title 23.5/10/2013 Barrel down inside standpipe. Slide gate difficult to operate.11/5/2012 burrow activity on WS slope. This crossing was listed in the USACE Periodic Inspection as ID# USACE_CESPK_MA07_2010_a_0160 no issues reported.

FIELD_STRUCT_DESC: 24-inch (not 42-inch) corrugated metal drainage pipe through the levee, 13.6 feet below the crown. Concrete distribution box with slide gate inside located on the waterside (WS). 36-inch pipe goes through the WS berm. (not found 2012) Concrete riser located across ditch unable to determine if standpipe is part of crossing appurtenances. [Additional Reference(s): DWR Levee Log, 2005]
FS Date: 5/16/2016 10:28:00 AM

LM Start	4.92	Rating **	M	Issue No.	85 (cont)
LM End	4.92	Issue Type +	En	Location *	WS

Overview of levee crown and slopes at crossing looking upstream.

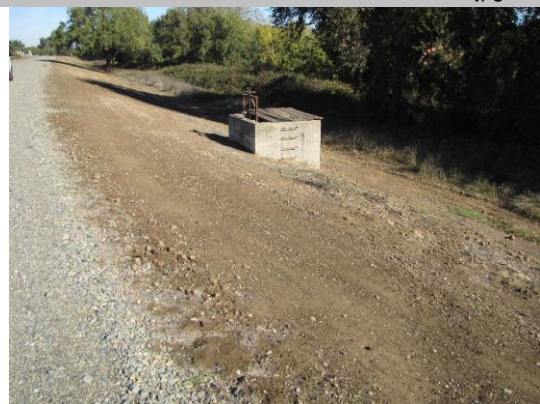
Photo 2 of 3 : UCIP_SP_2017_48003_65890.jpg

View of concrete distribution box with slide gate inside.

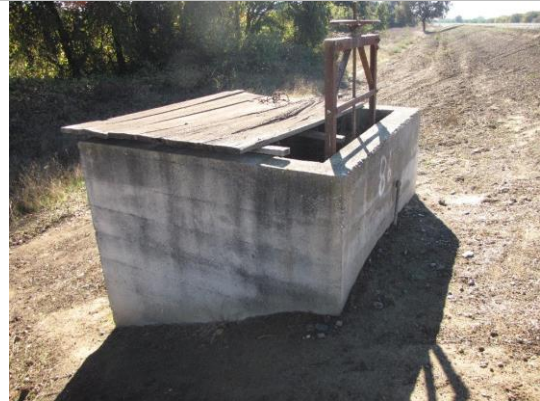
Photo 3 of 3 : UCIP_SP_2017_48003_65889.jpg

Comment Code						
Inspector Comment						
FS_ID:48003 DS_ID:16943 EP_NO: N/A Repair Type: Non-Urgent Crossing Status: Found UCIP Comments: 5/16/2016 Feather River West Levee Improvement Project--Levee currently under construction. Crossing, referenced as STA 1934+54, will be removed and replaced with a 12-inch pipe as indicated in the project Plans for Construction of Feather River West Levee Project, Project Area A, Feather River West Levee Improvement Plans, Sta 1765+00 to 2368+26, Volume 3 of 5.6/10/2015 Pipe has been removed during the SBFCA project. It was originally listed to be replaced so it may be added back in on a later date.12/29/2014 Same as last inspection.5/19/2014 Same as last inspection.11/7/2013 Same as last inspection.5/13/2013 SBFCA project recommends relacing in accordance with title 23.5/10/2013 Barrel down inside standpipe. Slide gate difficult to operate.11/5/2012 burrow activity on WS slope. This crossing was listed in the USACE Periodic Inspection as ID# USACE_CESPK_MA07_2010_a_0160 no issues reported. FIELD_STRUCT_DESC: 24-inch (not 42-inch) corrugated metal drainage pipe through the levee, 13.6 feet below the crown. Concrete distribution box with slide gate inside located on the waterside (WS). 36-inch pipe goes through the WS berm. (not found 2012) Concrete riser located across ditch unable to determine if standpipe is part of crossing appurtenances. [Additional Reference(s): DWR Levee Log, 2005] FS Date: 5/16/2016 10:28:00 AM

Close up view of distribution box on LS.

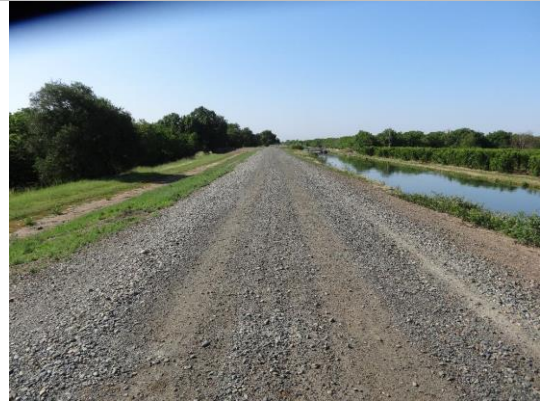
Photo 1 of 3 : UCIP_SP_2017_49918_65897.jpg

Comment Code					
Inspector Comment					
FS_ID:49918 DS_ID:23095 EP_NO: N/A Repair Type: Urgent Crossing Status: Found UCIP Comments: 5/16/2016 Feather River West Levee Improvement Project--Levee currently under construction. (DWR Sutter Yard - afreitag)6/10/2015 Still damaged at WS slope. Wires are still exposed but crossing is listed to be replaced sometime during the SBFCA project. (DWR Sutter Yard - afreitag)12/29/2014 Same as last inspection. (DWR Sutter Yard - afreitag)5/19/2014 Same as last inspection. (DWR Sutter Yard - afreitag)11/7/2013 More damage has occurred to power wires. Live wires are now exposed. Power company is aware of the problem and are going to fix it. (DWR Sutter Yard - afreitag)5/9/2013 Appeared to be damaged where it exits the WS slope, minor settling on LS toe, unable to obtain permit. SBFCA project recommends replacing in accordance with title 23. (DWR UCIP - omagana) FIELD_STRUCT_DESC: 2.5-inch steel electrical conduit through the levee, 3-4 feet below the crown. No permit has been identified since crossing was field discovered in 2012. FS Date: 5/16/2016 10:28:00 AM

LM Start	5.16	Rating **	U	Issue No.	86 (cont)
LM End	5.16	Issue Type +	En	Location *	WS

Overview of crossing from crown looking D/S

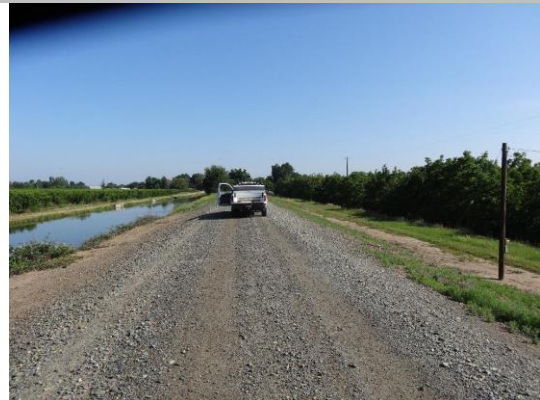
Photo 2 of 3 : UCIP_SP_2017_49918_65896.jpg

Overview of crossing from crown looking U/S

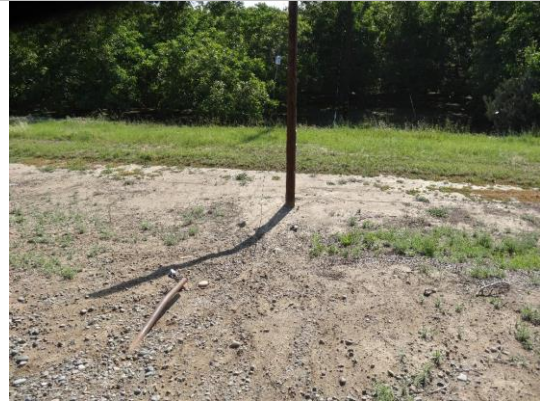
Photo 3 of 3 : UCIP_SP_2017_49918_65895.jpg

Comment Code						
Inspector Comment						
FS_ID:49918 DS_ID:23095 EP_NO: N/A Repair Type: Urgent Crossing Status: Found UCIP Comments: 5/16/2016 Feather River West Levee Improvement Project--Levee currently under construction. (DWR Sutter Yard - afreitag)6/10/2015 Still damaged at WS slope. Wires are still exposed but crossing is listed to be replaced sometime during the SBFCA project. (DWR Sutter Yard - afreitag)12/29/2014 Same as last inspection. (DWR Sutter Yard - afreitag)5/19/2014 Same as last inspection. (DWR Sutter Yard - afreitag)11/7/2013 More damage has occurred to power wires. Live wires are now exposed. Power company is aware of the problem and are going to fix it. (DWR Sutter Yard - afreitag)5/9/2013 Appeared to be damaged where it exits the WS slope, minor settling on LS toe, unable to obtain permit. SBFCA project recommends replacing in accordance with title 23. (DWR UCIP - omagana) FIELD_STRUCT_DESC: 2.5-inch steel electrical conduit through the levee, 3-4 feet below the crown. No permit has been identified since crossing was field discovered in 2012. FS Date: 5/16/2016 10:28:00 AM

WS slope

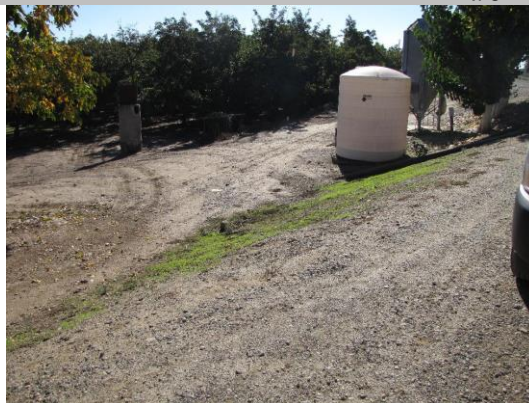
Photo 1 of 2 : UCIP_SP_2017_48815_65903.jpg

FS_ID:48815
DS_ID:16920
EP_NO: N/A
Repair Type: Non-Urgent
Crossing Status: Indicator Found
UCIP Comments: 5/16/2016 Feather River West Levee Improvement Project--Levee currently under construction. Crossing, referenced as STA 1956+20, will be removed and replaced with a 36-inch pipe as indicated in the project Plans for Construction of Feather River West Levee Project, Project Area A, Feather River West Levee Improvement Plans, Sta 1765+00 to 2368+26, Volume 3 of 5.6/10/2015 Unable to locate any signs of this crossing during this inspection. Looks to have been removed for the SBFCA project.12/29/2014 Same as last inspection.5/19/2014 Same as last inspection.11/7/2013 Same as last inspection.5/13/2013 SBFCA project recommends relacing in accordance with title 23.5/10/2013 Same as last inspection.11/5/2012 No access to LS--residential property; unable to determine the type of abandonment for this crossing; need to determine if there is a positive closure device on WS. This crossing was listed in the USACE Periodic Inspection as ID# USACE_CESPK_MA07_2010_a_0173 unknown.

View of WS.

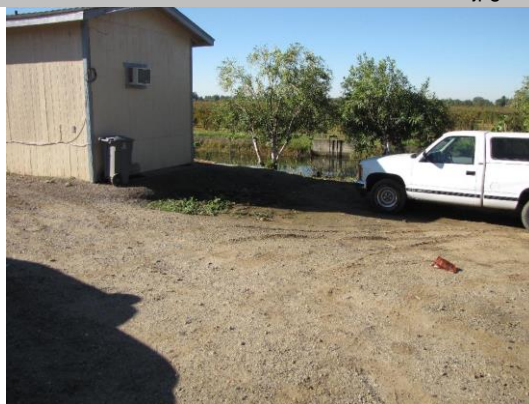
Photo 2 of 2 : UCIP_SP_2017_48815_65902.jpg

View of LS--no access.

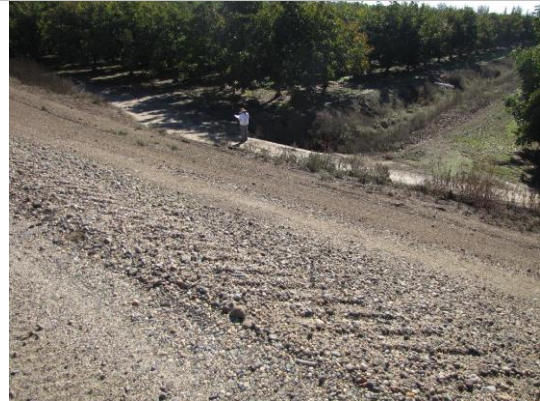
Photo 1 of 3 : UCIP_SP_2017_48005_65904.jpg

FS_ID:48005
DS_ID:16922
EP_NO: N/A
Repair Type: Non-Urgent
Crossing Status: Found
UCIP Comments: 5/16/2016 Feather River West Levee Improvement Project--Levee currently under construction. Crossing, referenced as STA 1961+03, will be removed as indicated in the project Plans for Construction of Feather River West Levee Project, Project Area A, Feather River West Levee Improvement Plans, Sta 1765+00 to 2368+26, Volume 3 of 5. The 2-60 inch pipes will be replaced with a single 36-inch pipe.6/10/2015 Sediment still blocking the flap gates on WS. LS inlet being overgrown by vegetation in the ditch.12/29/2014 Same as last inspection.5/19/2014 Same as last inspection.11/7/2013 Same as last inspection.5/13/2013 SBFCA project recommends relacing in accordance with title 23.5/10/2013 Same as last inspection.11/5/2012 Sediment blocking flap gates on WS--need to clear sediment. This crossing was listed in the USACE Periodic Inspection as ID# USACE_CESPK_MA07_2010_a_0180 no issues reported.

View of WS. Concrete headwall located at levee toe.
